IMPORTANT NOTICE

TO ALL CUSTOMERS using POSI-PLUS model 500 AERIAL DEVICES

October 14, 2020,

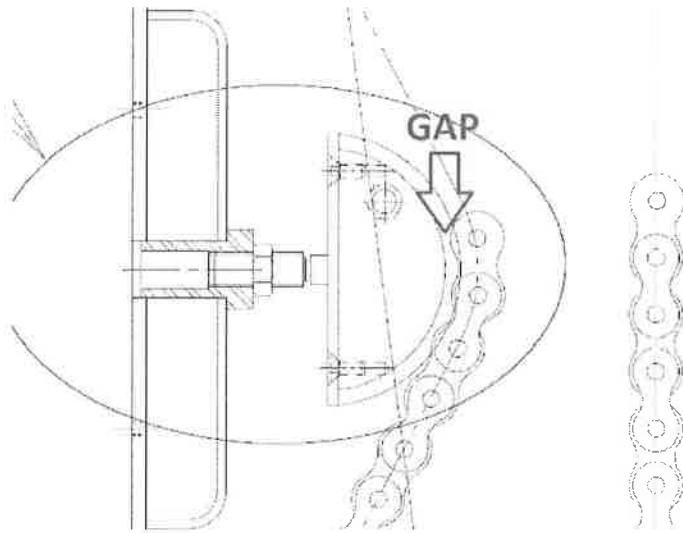
Figure 1

Specifically, the knuckle (delta) chain tensioner assembly must be inspected to detect any damaged or worn-out parts. Any damaged or worn-out parts must be replaced.

1. Replace binder (500-7019-004) if either:
 - a. The chain outer plates rub against the inner circumference of the chain binder (Fig. 1)
 - b. The surface on which the chain rollers are rolling is not smooth or shows cracks.
2. Use a torque wrench at 90% (28 ft-lb) of the 31 ft-lb recommended torque on the bolt holding the chain binder in place. If the bolt is found loose, replace with a new one (100-006-293). Use Loctite #262 as per the leveling system schematic in the parts manual (Fig.2)
