Can new technologies **prevent struck-by injuries?**

Scan-Link system

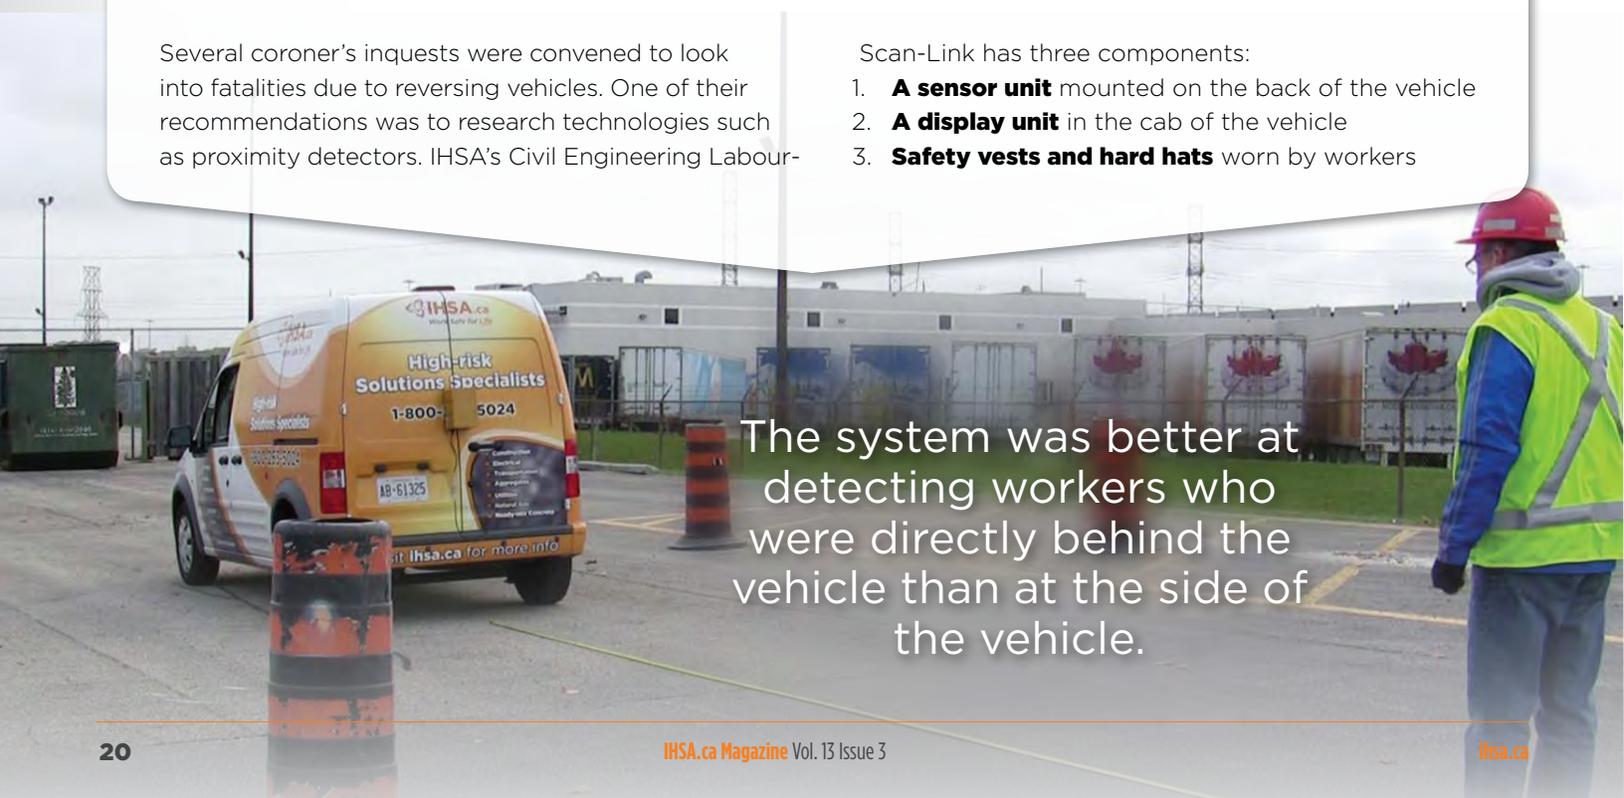
The system was better at detecting workers who were directly behind the vehicle than at the side of the vehicle.

- There was a slight delay from the time of detection to the time when the alarm sounded. So, depending on an operator's reaction time and a vehicle's braking distance, an operator might not be able to stop in time if a vehicle was moving fast.
- Our researchers tested detection ranges when workers were standing at three different angles to the back of the vehicle: 0° (directly behind), 45°, and 80°. The system was better at detecting workers who were directly behind the vehicle than at the side of the vehicle. The sensor sends out a conical signal, so as the angle of the worker to the vehicle increases, the detection range decreases.
- The system performed best when the workers were wearing an RFID-tagged vest and hard hat at the same time. It performed almost as well when just the vest was worn, but the detection range decreased significantly when the hard hat was worn alone.

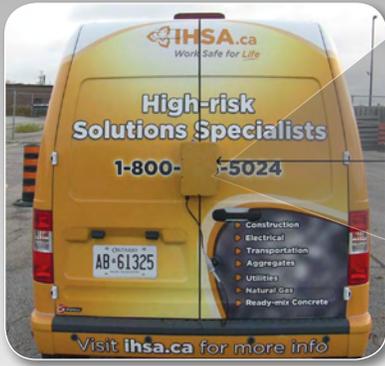
Sensor unit

1. **A sensor unit** mounted on the back of the vehicle
2. **A display unit** in the cab of the vehicle
3. **Safety vests and hard hats** worn by workers

Scan-Link uses a radio frequency broadcast from the sensor unit mounted on the back of the vehicle to detect any worker who is in the path of the reversing vehicle. Workers wear safety vests and hard hats equipped with radio frequency identification (RFID) tags. If the system detects an RFID tag within the reversing zone, the display unit in the cab alerts the operator with an alarm and a visual warning.
